CAA112(r) INSPECTION REPORT

Name: Simply Essentials Poultry	
Address: 901 North Main Street, Charles City, IA 50616	Date of Inspection: July 10, 2018
County: Floyd	Case No: 18IA0710
Phone: 641-228-4127	RMP No: 1000 0021 6214
High Risk: No	FRS No: 1100 4427 8689
CAA Title V: No	Program Level: Program 3
Mailing Address: 12980 Foster St., Overland Park, KS 66213	
Process: Anhydrous ammonia used for refrigeration

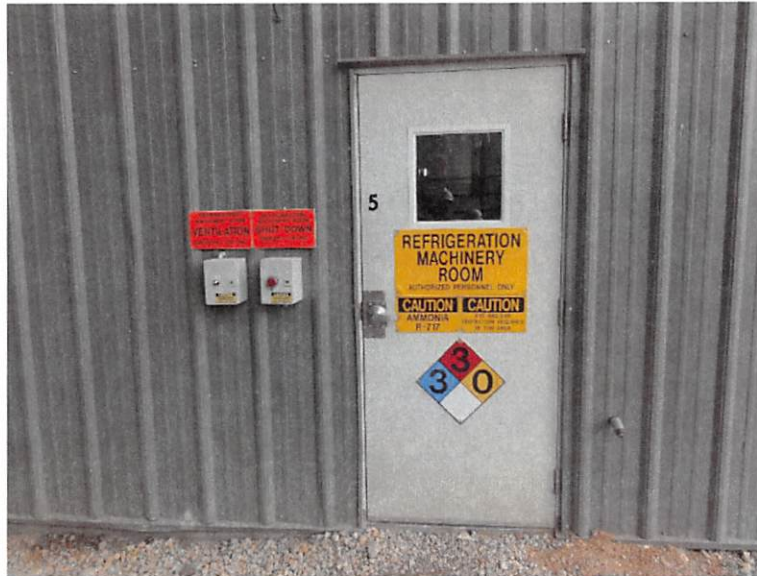
CASE NO. 18IA0710 Direction: <i>Not recorded</i>	DESCRIPTION	This photograph shows the entrance to the engine room of the cover process (an anhydrous ammonia refrigeration system).	1
	FACILITY	Simply Essentials Poultry	Date
	PHOTOGRAPHER	Robert Monnig	7/10/2018

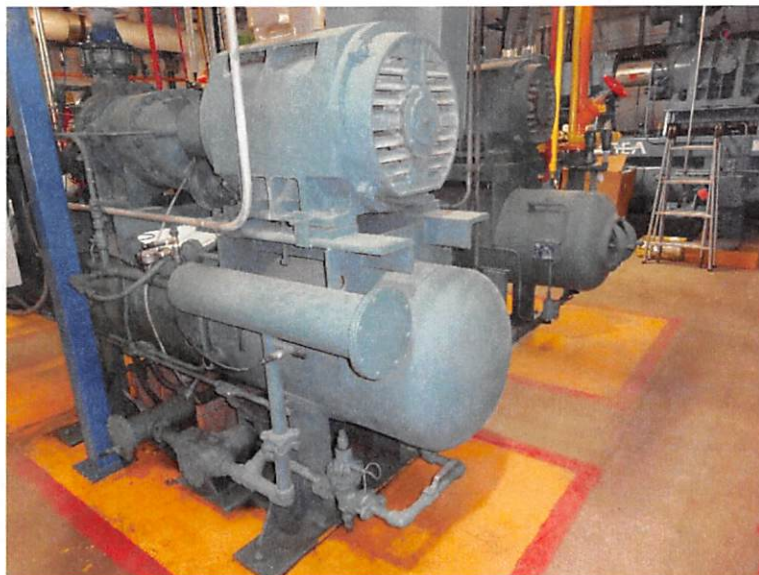
CASE NO. 18IA0710 Direction: <i>Not recorded</i>	DESCRIPTION	This photograph shows compressors in the engine room.	2
	FACILITY	Simply Essentials Poultry	Date
	PHOTOGRAPHER	Robert Monnig	7/10/2018

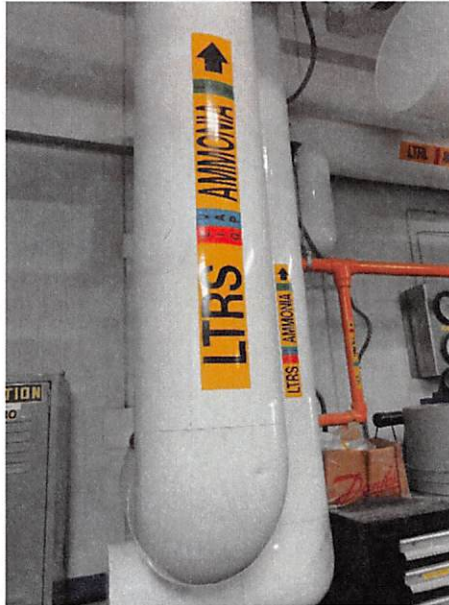
CASE NO. 18IA0710 Direction: <i>Not recorded</i>	DESCRIPTION	This photograph shows typical piping labeling observed in the engine room.	3
	FACILITY	Simply Essentials Poultry	Date
	PHOTOGRAPHER	Robert Monnig	7/10/2018

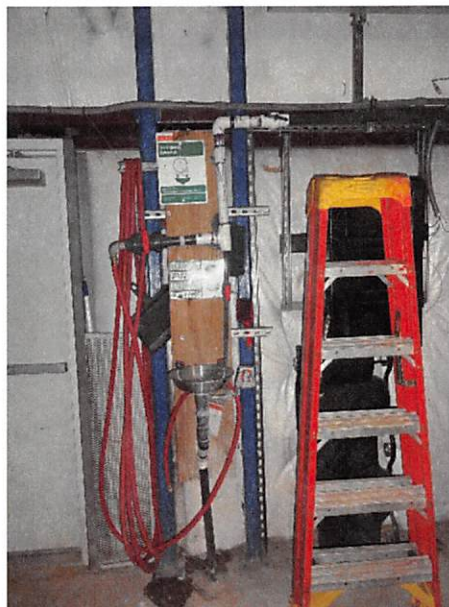
CASE NO. 18IA0710 Direction: <i>Not recorded</i>	DESCRIPTION	This photograph shows an eye wash station in the engine room.	4
	FACILITY	Simply Essentials Poultry	Date
	PHOTOGRAPHER	Robert Monnig	7/10/2018

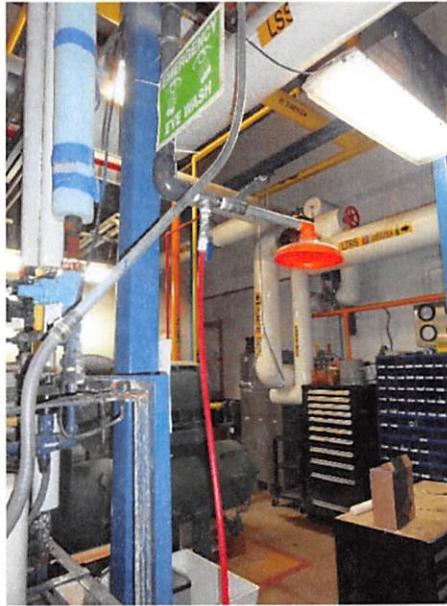
CASE NO. 18IA0710 Direction: <i>Not recorded</i>	DESCRIPTION	This photograph shows an emergency show inside the engine room.	5
	FACILITY	Simply Essentials Poultry	Date
	PHOTOGRAPHER	Robert Monnig	7/10/2018

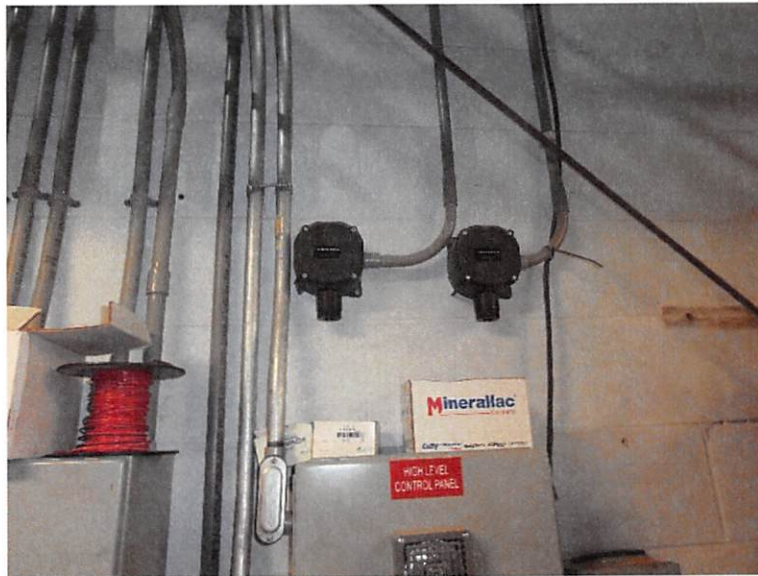
CASE NO. 18IA0710 Direction: <i>Not recorded</i>	DESCRIPTION	This photograph shows anhydrous ammonia sensors inside the engine room.	6
	FACILITY	Simply Essentials Poultry	Date
	PHOTOGRAPHER	Robert Monnig	7/10/2018

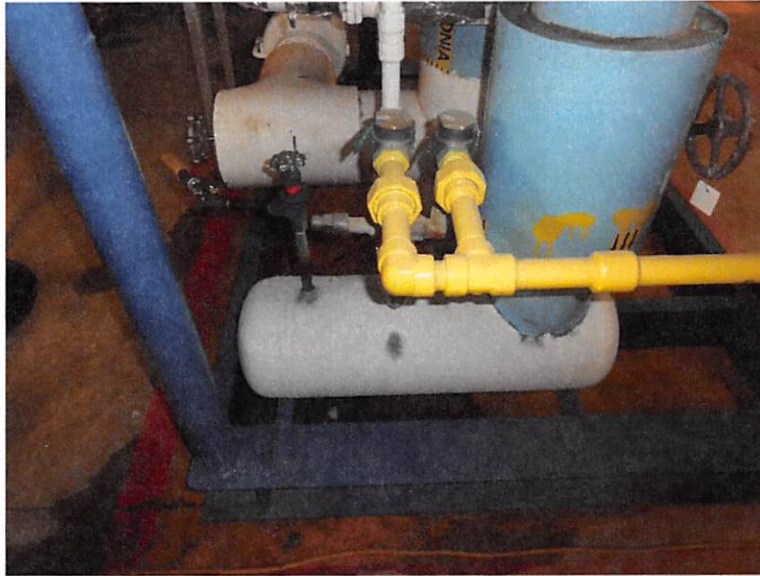
CASE NO. 18IA0710 Direction: <i>Not recorded</i>	DESCRIPTION	This photograph shows an oil pot equipped with a self-closing valve. A shut-off valve is installed in series with the self-closing valve.	7
	FACILITY	Simply Essentials Poultry	Date
	PHOTOGRAPHER	Robert Monnig	7/10/2018

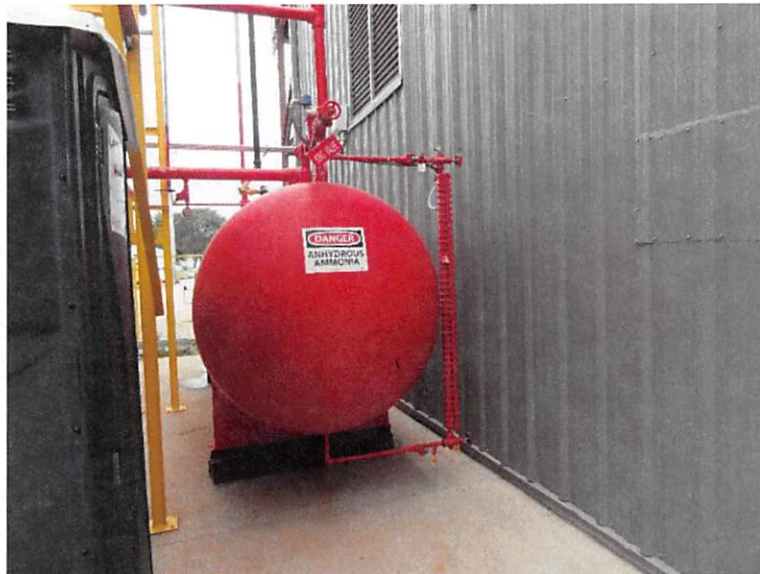
CASE NO. 18IA0710 Direction: <i>Not recorded</i>	DESCRIPTION	This photograph shows the high-pressure receiver outside of the engine room.	8
	FACILITY	Simply Essentials Poultry	Date
	PHOTOGRAPHER	Robert Monnig	7/10/2018

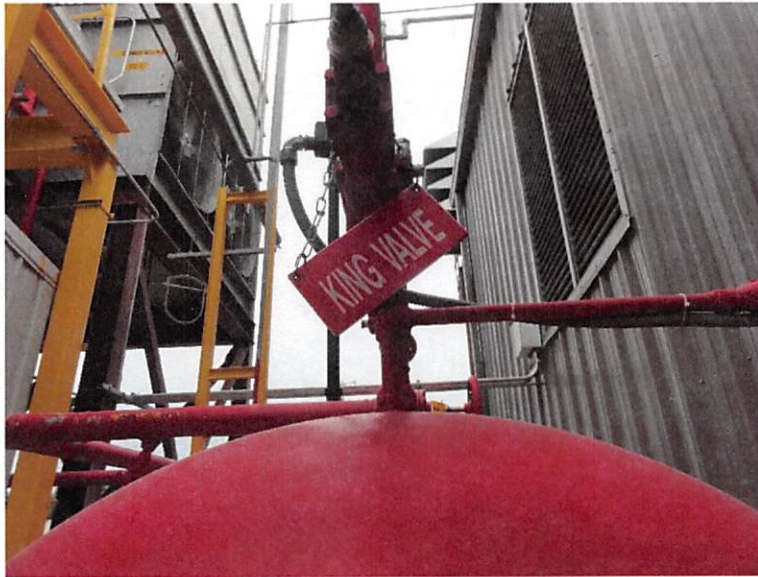
CASE NO. 18IA0710 Direction: <i>Not recorded</i>	DESCRIPTION	This photograph shows the top of the high-pressure receiver and the labeled king valve.	9
	FACILITY	Simply Essentials Poultry	Date
	PHOTOGRAPHER	Robert Monnig	7/10/2018

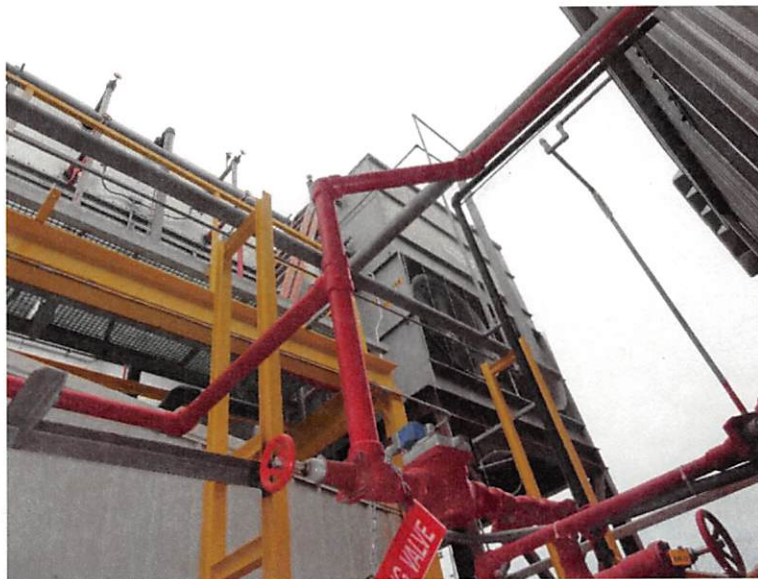
CASE NO. 18IA0710 Direction: <i>Not recorded</i>	DESCRIPTION	This photograph shows a roof-top condenser of the covered process.	10
	FACILITY	Simply Essentials Poultry	Date
	PHOTOGRAPHER	Robert Monnig	7/10/2018

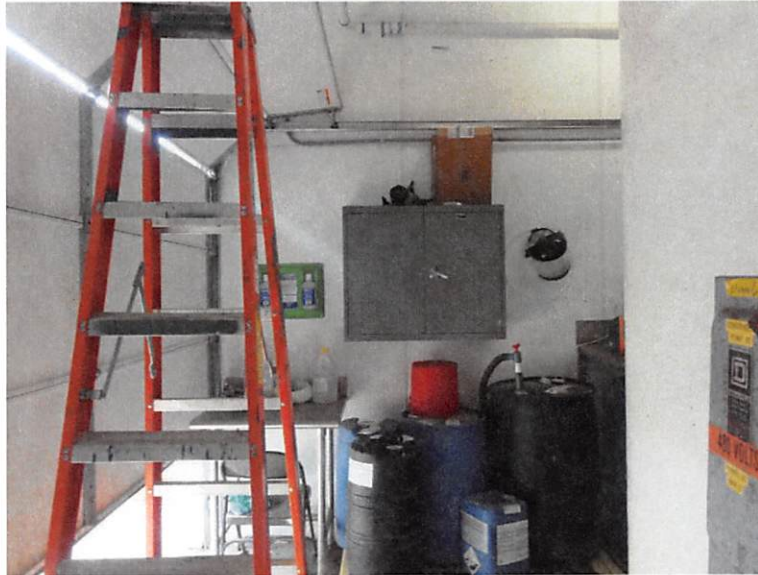
During the walk-through of the covered process, I observed that a safety shower and eyewash station were installed inside the engine room, but that no safety shower was installed outside of the engine room (I did observe eyewash bottles within a storage shed outside of the engine room). I noted that lack of a safety shower outside of the engine room contrasts with the recognized and generally accepted engineering practice (RAGAGEP) of installing and maintaining a safety shower outside of the engine room (see eyewash and safety shower requirements of IIAR 2-2014, 6.7.1, 6.7.2, and 6.7.3 and IIAR 2-2008A, 13.1.6). Based on this observation, I identified the following preliminary finding:

- 3. A safety shower is not installed outside of the machinery room, as required by 40 CFR 68.65(d)(2) and 68.73(d)(3).**

CASE NO. 18IA0710 Direction: <i>Not recorded</i>	DESCRIPTION	This photograph shows the interior of a storage shed located near the engine room. Emergency eye wash bottles are mounted on the interior wall of the shed.	11
	FACILITY	Simply Essentials Poultry	Date
	PHOTOGRAPHER	Robert Monnig	7/10/2018

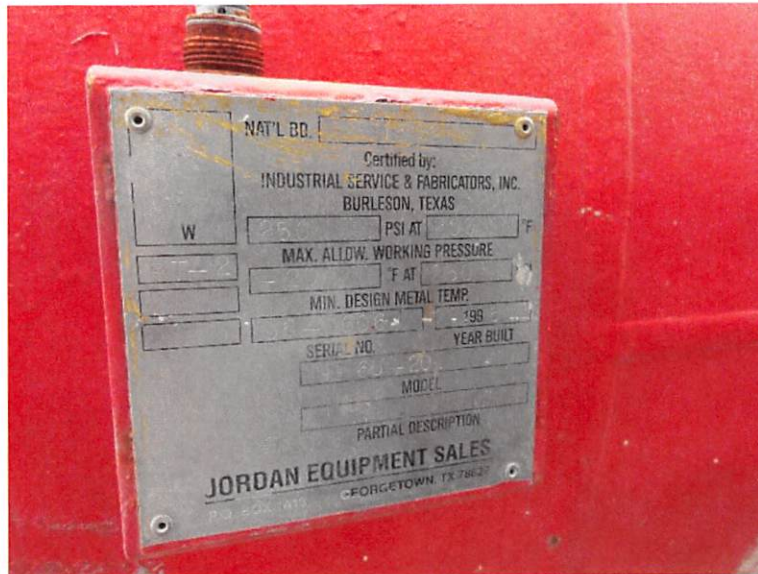
CASE NO. 18IA0710 Direction: <i>Not recorded</i>	DESCRIPTION	This photograph shows the data plate of the high-pressure receiver. The data plate indicates a build year of 1996.	12
	FACILITY	Simply Essentials Poultry	Date
	PHOTOGRAPHER	Robert Monnig	7/10/2018

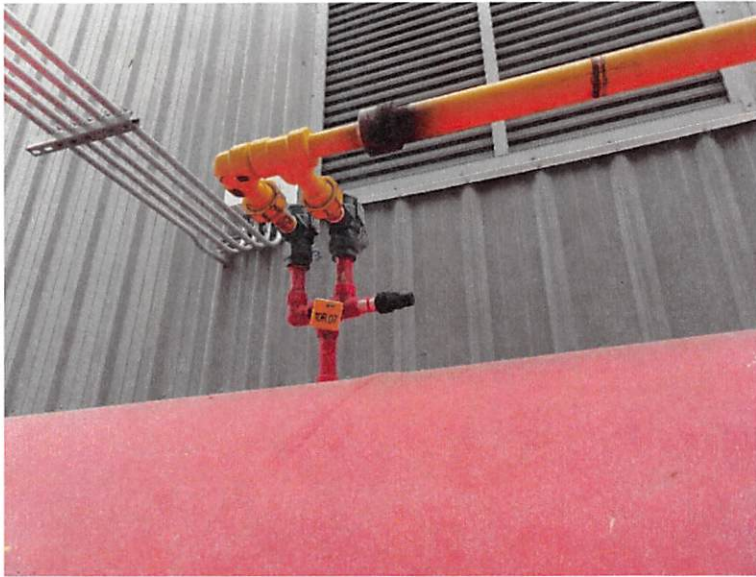
CASE NO. 18IA0710 Direction: <i>Not recorded</i>	DESCRIPTION	This photograph shows dual relief valves installed on the high-pressure receiver.	13
	FACILITY	Simply Essentials Poultry	Date
	PHOTOGRAPHER	Robert Monnig	7/10/2018

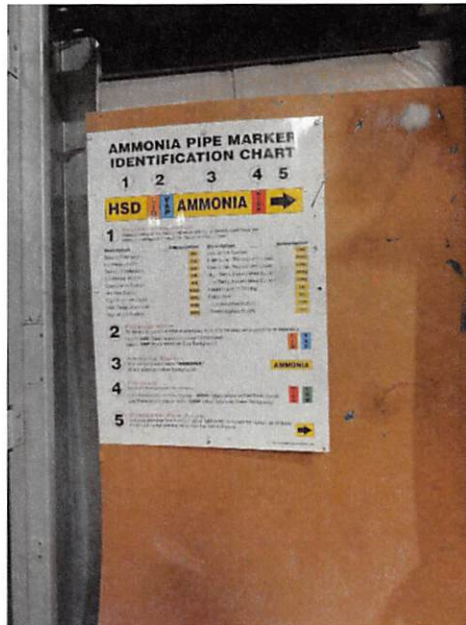
CASE NO. 18IA0710 Direction: <i>Not recorded</i>	DESCRIPTION	This photograph shows an ammonia pipe marker identification chart posted inside the engine room.	14
	FACILITY	Simply Essentials Poultry	Date
	PHOTOGRAPHER	Robert Monnig	7/10/2018

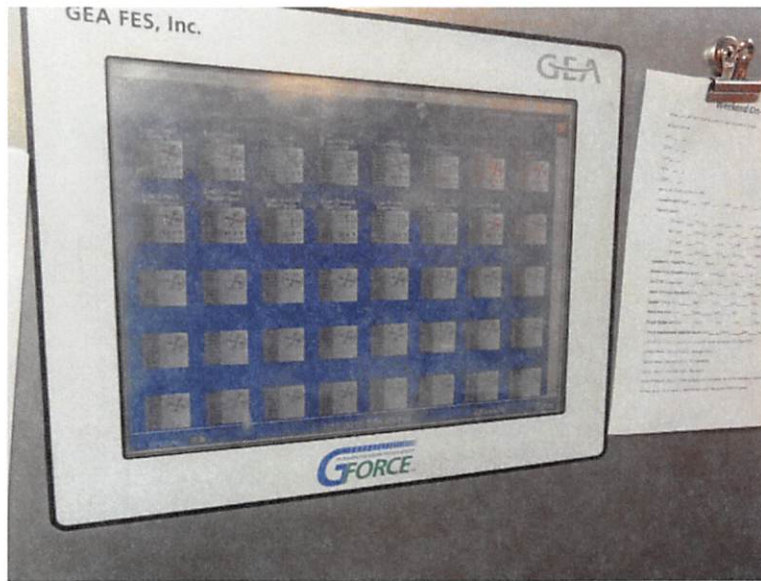
CASE NO. 18IA0710 Direction: <i>Not recorded</i>	DESCRIPTION	This photograph shows the human-machine interface touchscreen of the refrigeration control system.	15
	FACILITY	Simply Essentials Poultry	Date
	PHOTOGRAPHER	Robert Monnig	7/10/2018
